EFFECT OF ZINC ON THE SULPHIDATION REACTION IN MARINE GAS TURBINES

D.R.E.A. REPORT 80/2

RESEARCH AND DEVELOPMENT BRANCH ORPARTMENT OF NATIONAL DIPPINGS CANADA

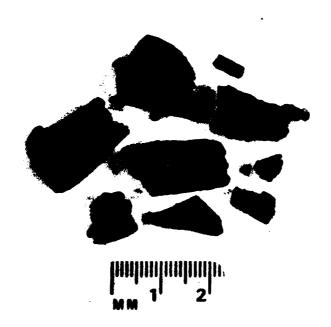
Table II, which shows the results of exposure to a 90/10 mixture of Na_2SO_4 and NaCl, indicates that 12 of 18 samples were completely oxidized in exposure times of 16 to 90 hours (Figure 6). Only two blades showed no deterioration after exposure times of 40 and 70 hours although several others displayed a low level of sulphidation. In marked contrast, the results of Table III, for exposures to mixtures containing either 2.5 or 5.0 percent $2nSO_4$ for times from 30 to 112 hours, show nil or little wastage in all 20 cases and the wastage that occurred was ascribed to normal high temperature oxidation.

FIGURE 6: Solar "Saturn" 1st stage turbine blade completely oxidized after 30 hours.
